# FACILITY COMPLIANCE INSPECTION REPORT

## Division of Waste Management Solid Waste Section

**Date of Site Inspection:** 10/19/2012

Penland School of Crafts  
 PO Box 37  
 Penland, NC 28765

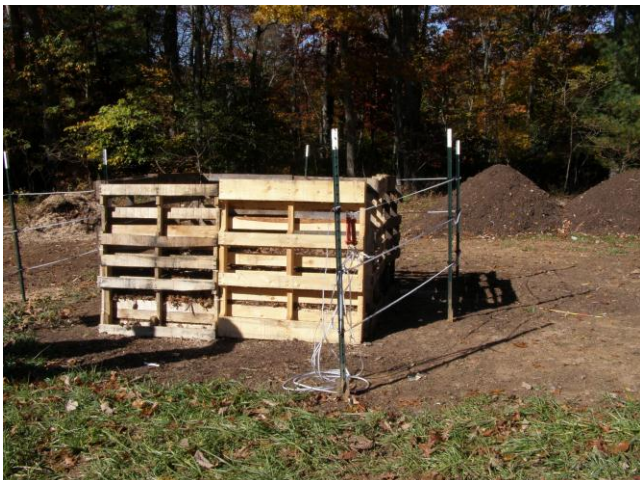
**View of layered food waste in bin.**  
**Digital photographs taken by Deb Aja on 10/19/2012.**

5. The composting process is as follows:
  - a. The layered food waste is layered in the bin and remains static in the bin for 2 weeks to meet the temperature requirements of .1406(11).

12. There were a few yellow jackets in the area during the inspection. Flies and other vectors were not observed. It is recommended that a screen be placed over the bin for additional vector control and to prevent cross contamination from material in-process to finished compost.

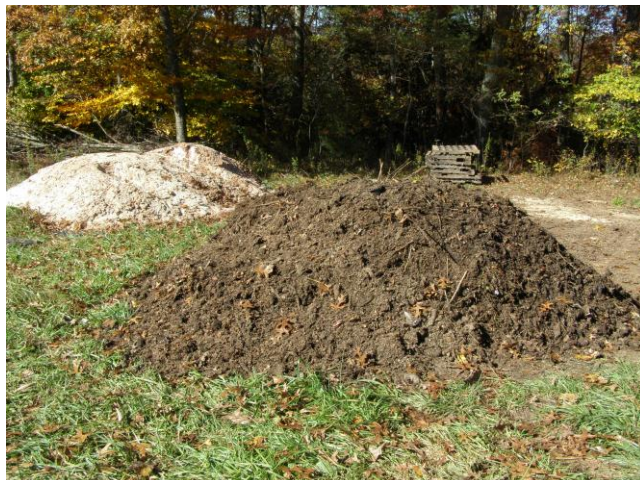
**View of a windrow in process.**

- b. The material in the bin is then placed into a windrow which is turned at least 5 times in a 15 day period and meets the temperature requirements of .1406(12)(A) for further pathogen reduction.

13. Excess moisture was effectively controlled by sawdust placed downgradient of the bin. There was no moisture/leachate present around the bin, windrows, or cure piles. During wet-weather conditions the bin and windrows should be observed to ensure that leachate is contained. Surface water may be directed away from composting operation areas by the use of soil berms or other measures.
